ANNUAL REPORT FOR 2003

**Gurley Mitigation Site
Greene County
Project No. 8.T340306
TIP No. R-1023WM**

Prepared By:
Office of Natural Environment & Roadside Environmental Unit
North Carolina Department of Transportation
December 2003

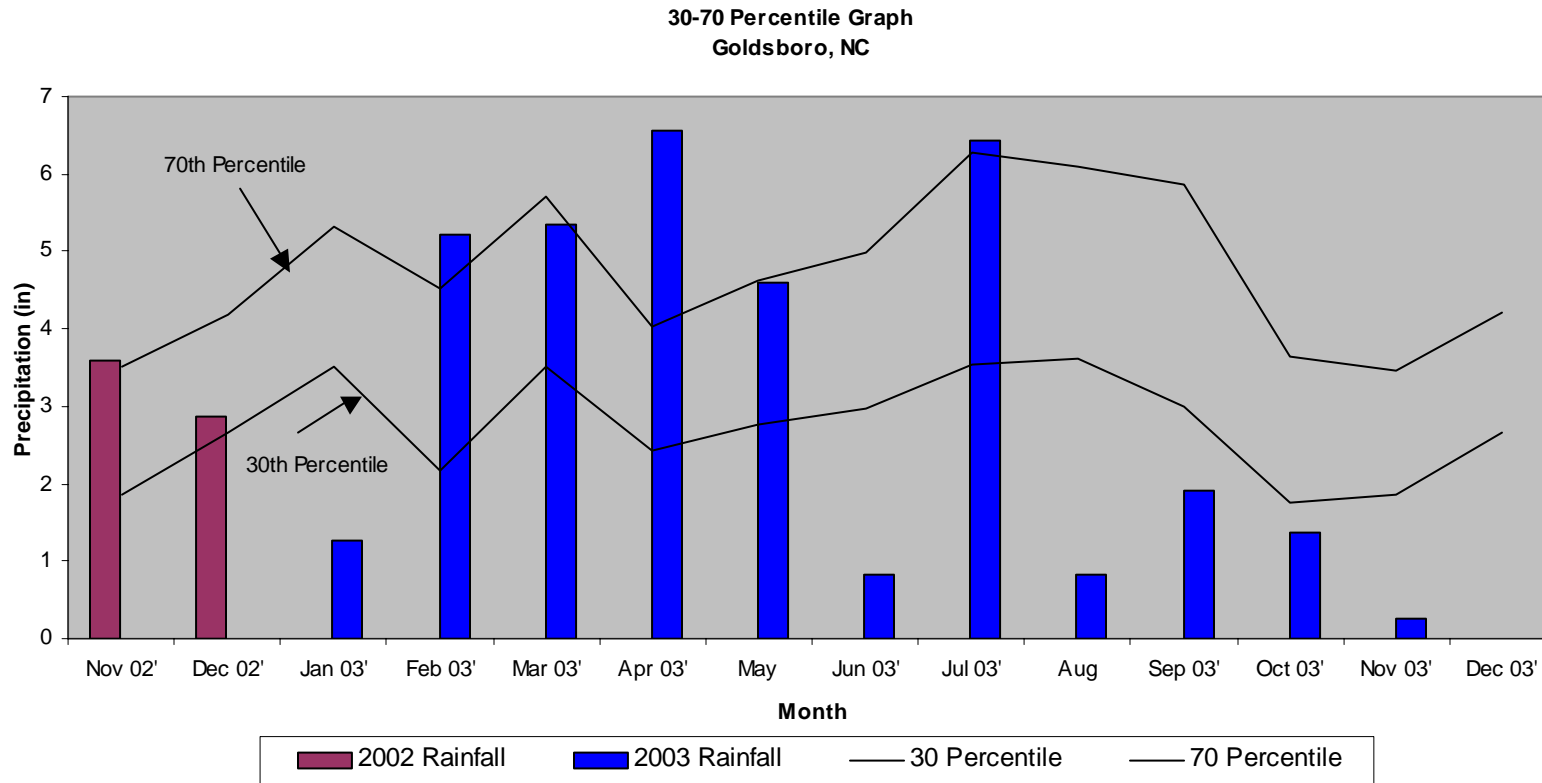
Figure 4. 30-70 Percentile Graph, Goldsboro, NC

Figure 4 is a comparison of 2002-2003 monthly rainfall to historical precipitation for the area. The two lines represent the 30th and 70th percentiles of monthly precipitation for Goldsboro, NC. The bars are the monthly rainfall totals for 2002 and 2003. The NC State Climate Office provided the historical data.

For the 2003-year, November (02'), February, April, and July experienced above average rainfall. The months of January, June, August, September, October, and November recorded below average rainfall for the site. December (02'), March, and May experienced average rainfall. Overall, 2003 experienced an average rainfall year.

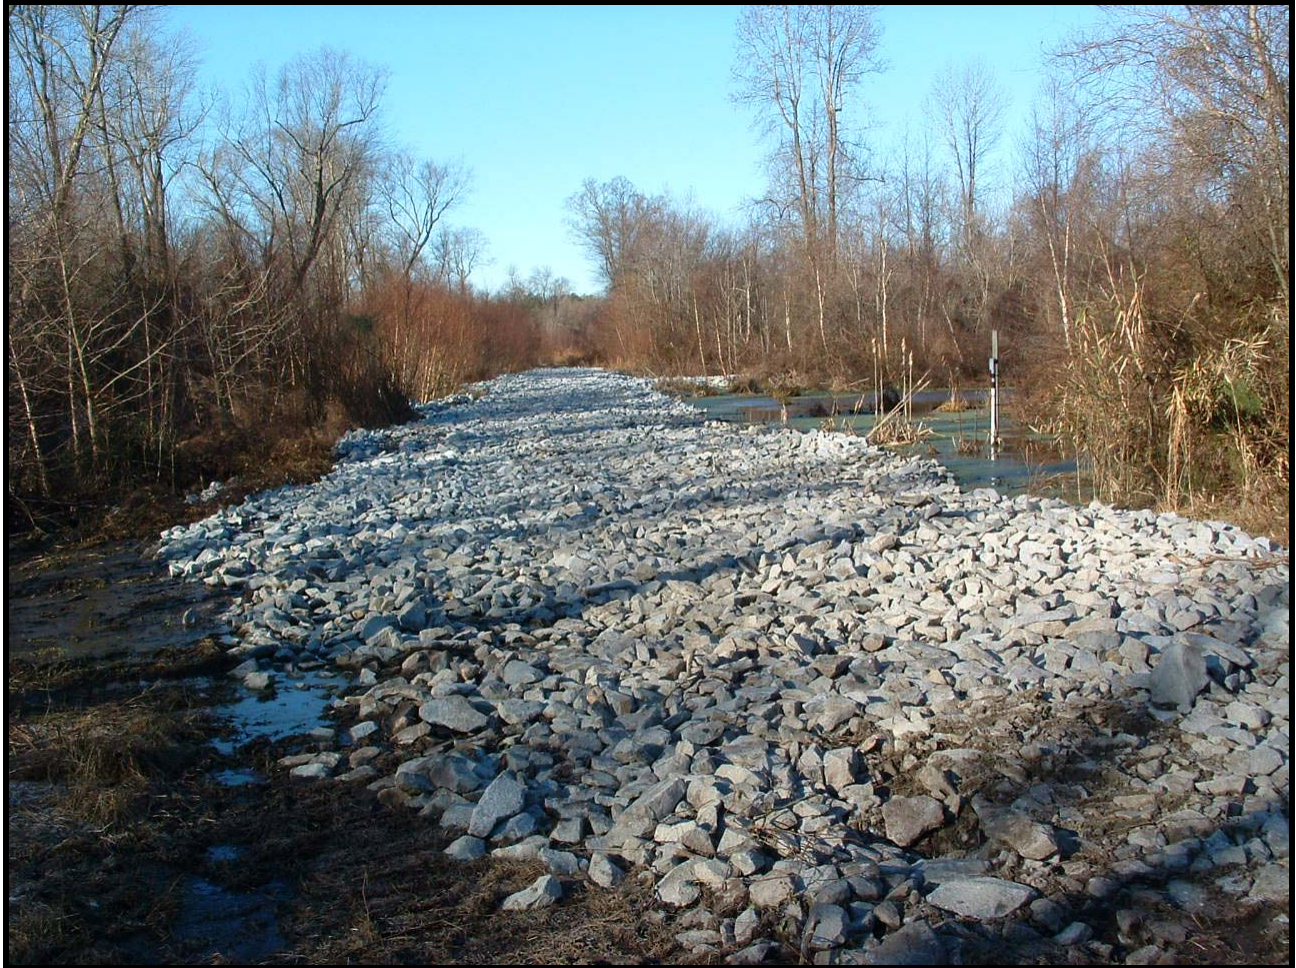
UPLAND LEVEE REPAIR PICTURE

Repairs were made to portions of the upland levee area in December 2003. The repairs were needed due to extensive washes along a portion of the levee adjacent to the beaver impoundment (See photo Appendix B). A gate will be added on the levee to prevent further public access.
